## Memo - Baseline Displacement / Brabantwater - Kruisland

Reference nr.: 2410023.03 / HM.AU.MV

## Executive summary

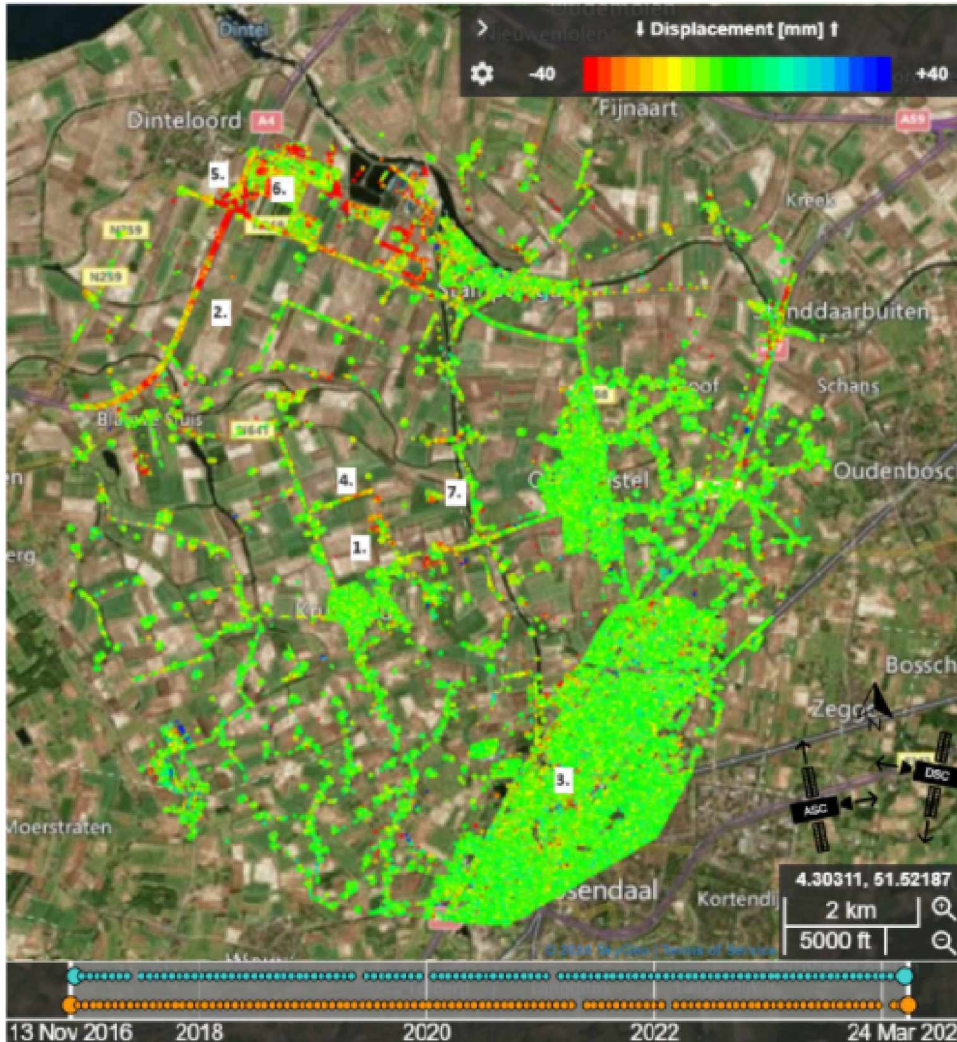
## Kruisland area of interest

Location	Address
1	5.1.2.e Kruisland
2	A4 next to Potmarkreek
3	Brug Zuid Hollandweg over Nieuwe Rosendaalsche vliet
4	5.1.2.e Kruisland
5	Intersection A4 and Noordlangeweg
6	5.1.2.e Dinteloord
7	5.1.2.e Kruisland

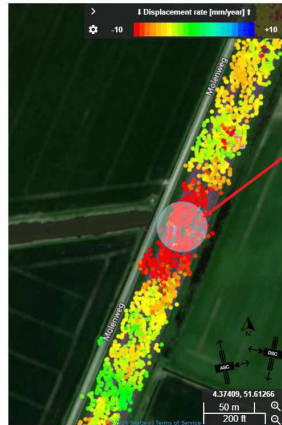
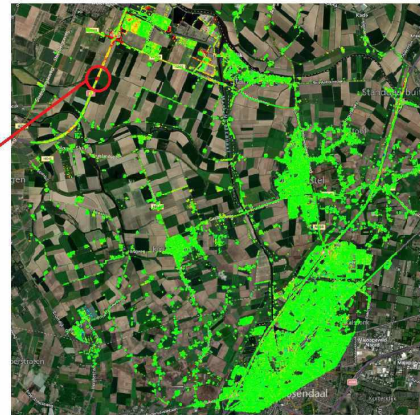
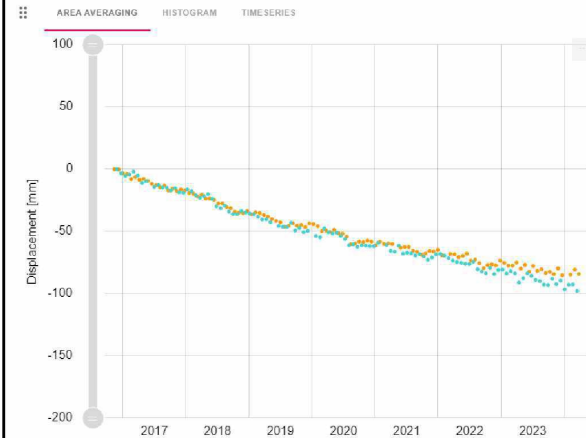
## 2. Shallow compaction over filled-in creek(roads) (A4 next to Potmarkreek)

The displacement rate on this road section is higher than neighboring areas, reaching up to velocities of  $\sim -12.5$  mm/y, as compared to the rest of the road, which is around  $-3.7$  mm/y.

**Description:** On this road, a localized higher subsidence velocity is observed. This correlates with the location of a former Creek that has been filled-in. The disturbed soil layers tend to compact over time. Initially, this compaction can be rapid but typically decelerates as the soil reaches a new equilibrium. Soil settling is a natural consequence of the re-compaction process after being disturbed.

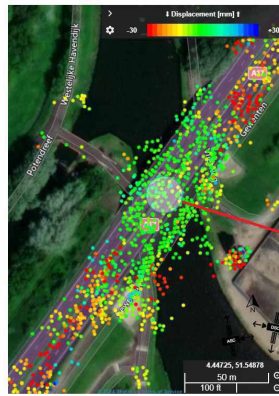
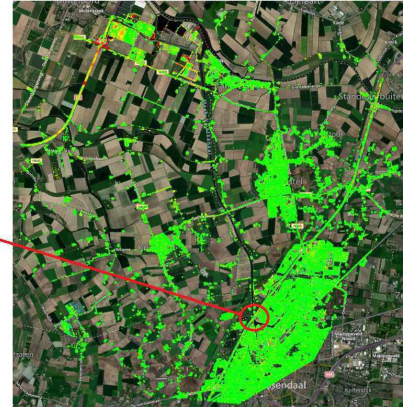
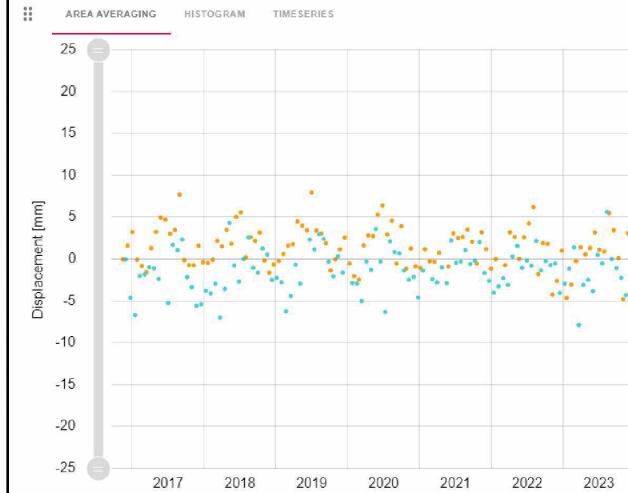
### 3. Seasonality due to thermal expansion (Brug Zuid Hollandweg over Nieuwe Roosendaalsche vliet)

Seasonal variations are around 5 - 7 mm, which is not the case for the surrounding areas, with mainly linear displacements.

**Description:** Seasonality is observed where temperature is expected to play a role. Thermal expansion and contraction of materials (such as asphalt in roads, steel in bridges, and some building materials) lead to cyclic displacements. These movements are usually periodic, corresponding to seasonal temperature variations. In this case, subsidence and uplift correspond to winter and summer periods.

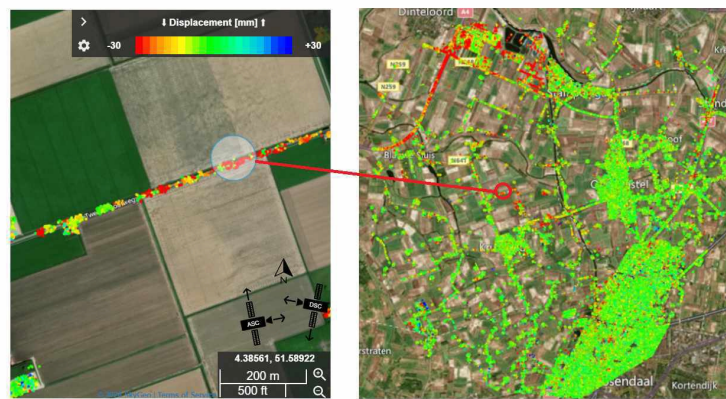
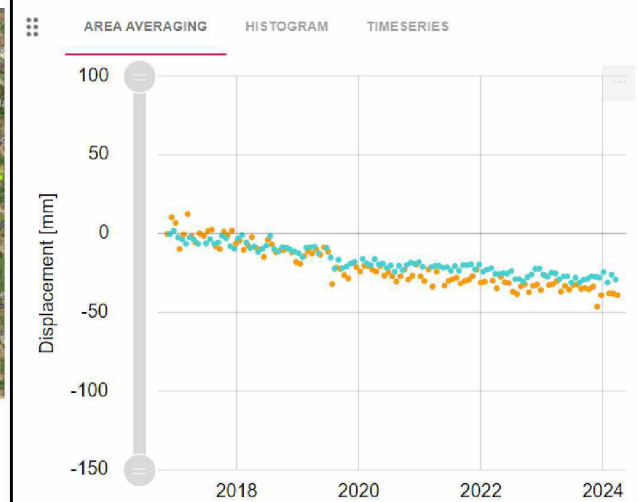
#### 4. Generic long-term shallow compaction (Tweede Boutweg, Kruisland)

The displacement can be very localized and can correlate with local soil type. The displacement rates can be between  $\sim -2.5$  and  $-6$  mm/y

**Description:** Overall, we observe gradual and continuous subsidence due to natural soil compaction processes. Factors contributing include soil consolidation under the weight of overburden and ongoing sedimentary processes, common in The Netherlands.

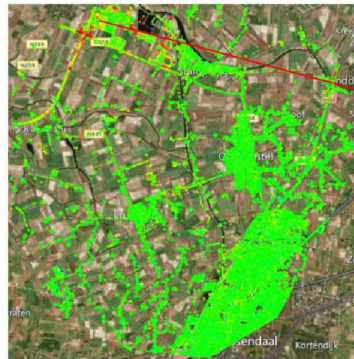
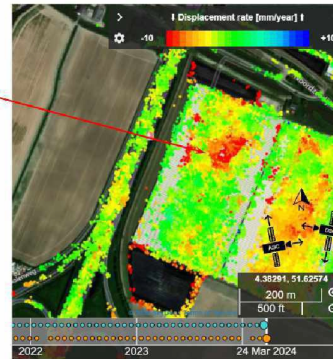
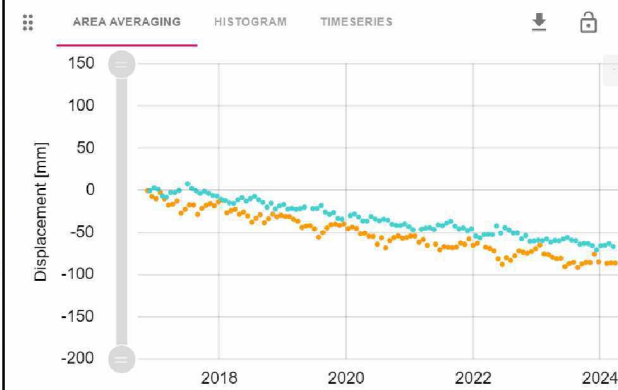
**6. Greenhouses.  
(Noordzeedijk  
120, Dinteloord).**

**Description:** On the roof of the greenhouses, the displacement rate reaches up to velocities of  $\sim -12$  mm/y. This displacement indicates that the structure most likely does not have a deeper foundation. The spatial difference most likely indicates spatial variations in the soil properties and the corresponding bearing capacity and/or compaction. In the time series also a seasonal effect can be seen which corresponds to the thermal expansion of the metal structure of the greenhouse and shows opposite signals for the different satellite-tracks due to the different look-direction.

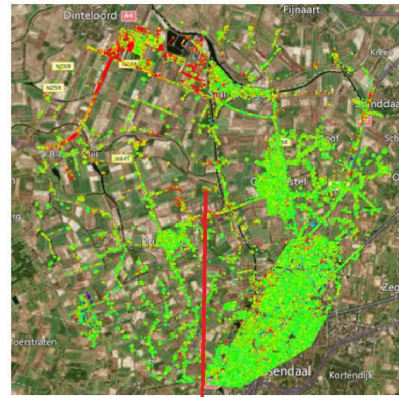
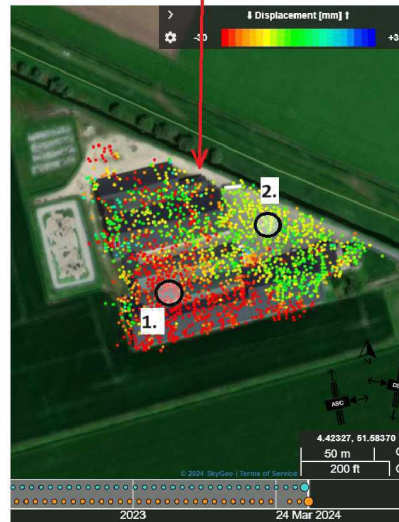
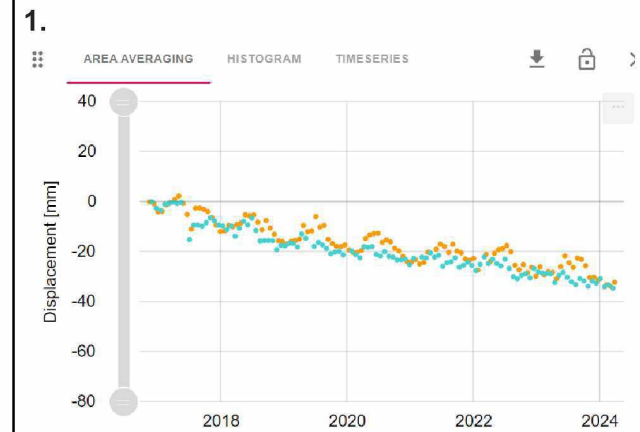
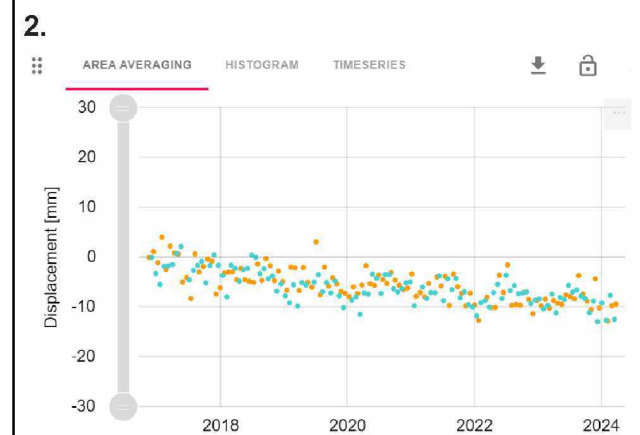
**7. Displacement Magnitude Differences in Urban Areas: Impact of Foundation Types (Kleine Bolspolder 3, Kruisland)**

**Description:** We observe different displacement magnitudes within the same location. Time series show that the barn (1), exhibits more than twice as much displacement (up to ~5 mm/yr) as the terrain next to it (up to ~2 mm/yr). The reason for this can be local variations in soil properties and compaction occurring due to the additional load of the barn.
